**UNITED STATES DISTRICT COURT
FOR THE DISTRICT OF MASSACHUSETTS**

Case No.: 05 CV 10155 PBS

**PLAINTIFFS' OPPOSITION TO
DEFENDANTS' MOTION FOR
SUMMARY JUDGMENT**

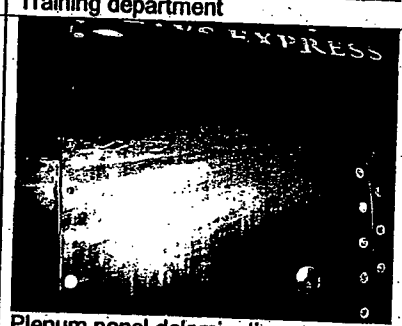
Plenum panel delamination

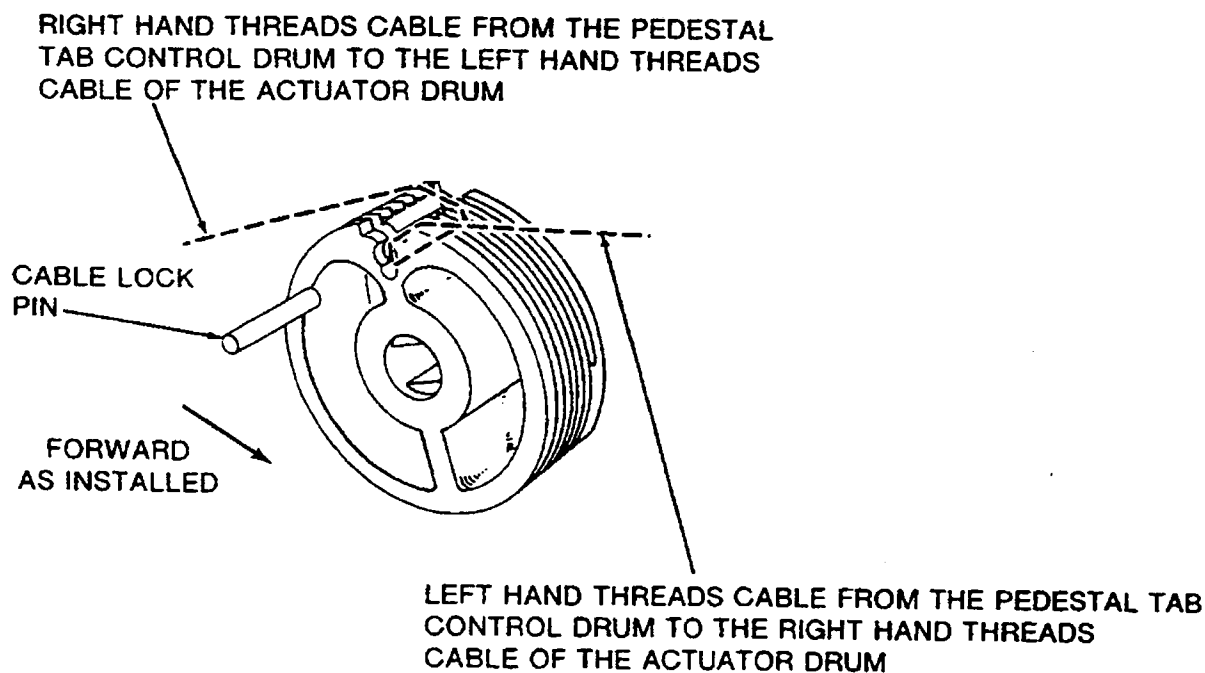
Elevator Tab Control Cable Winding

- a. Trim drum illustration is incorrect in REPS R9 Ch 27-30-04, Figure 201
- b. REPS R9 Ch 27-30-09 contains no link to the operational check of the elevator trim.
- c. Some mismatches of elevator trim tab actuators can cause the elevator trim cable to pop off the trim drum
- d. Other mistakes, typographical errors or incorrect references

Actions	Compliance	Procedures
<p>(1) Using pen and ink, mark the applicable figure in the maintenance manual as referenced below. The depiction in the referenced figures is incorrect for the elevator trim drum only and depicts the cable drum at 180 degrees from the installed position and shows the open, keyed side of the drum instead of the flat side of the drum. Insert corrected figure (Figure 1 of this AD) into the applicable maintenance manual and identify it accordingly:</p> <p>(i) Figure 9 of Chapter 27-10-00 of the Model 1900/1900C Airliner Maintenance Manual (114-590021-7B) Clearly note in pen that existing portion of Figure 9 is correct for the aileron trim drum only and insert corrected figure (Figure 1 of this AD) marked in pen as correct for the elevator trim drum only; or</p> <p>(ii) Mark out Figure 201 of Chapter 27-30-04 of the Model 1900D Airliner Maintenance Manual (125-590000-15). Insert corrected figure (Figure 1 of this AD)</p>	<p>Before the next time you have maintenance done on the elevator trim system.</p>	<p>As specified in Raytheon Safety Communiqué No. 234, dated September 2003.</p>

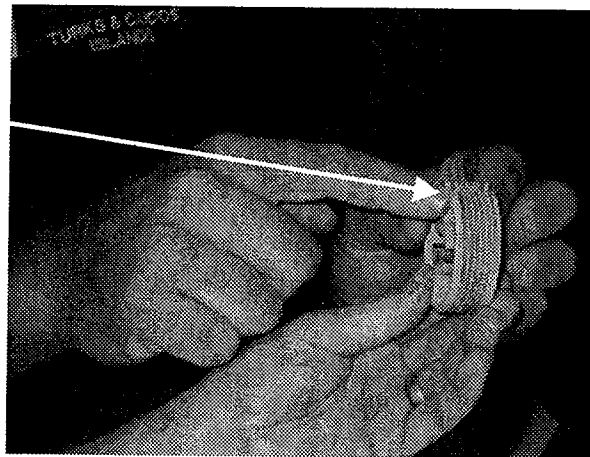
Figure 2 Elevator trim cables

- They then wrapped the drum using diagram 201 ("Elevator Tab Control Cable Winding") from maintenance manual, section 27-30-04-210, as a guide. See picture below (Figure 2) showing where they positioned the left hand threaded cable.

Left hand threaded cable positioned here as shown by mechanic
